**OBJECTION OF CECILIA BROWN TO DEBTORS’ NOTICE OF AMENDED
EXECUTORY CONTRACTS AND UNEXPIRED LEASES SUBJECT TO
POSSIBLE ASSUMPTION AND ASSIGNMENT AND PROPOSED CURE
AMOUNTS**

Inspection Report

Property Address:
2731 N. Grandview
Odessa Texas

The tenant maintenance inspection was performed by national property inspections on the neighbors emergency room facility at 2731 Grandview Odessa Texas. The walk-through survey was done August 16 2018. At the time of the inspection the building was occupied by the tenants and was operational at the time of inspection. Property sits on almost 1 acre with a building size of 8000 ft.building consist of a steel framing with the synthetic stucco construction and was overall good condition at time of inspection.

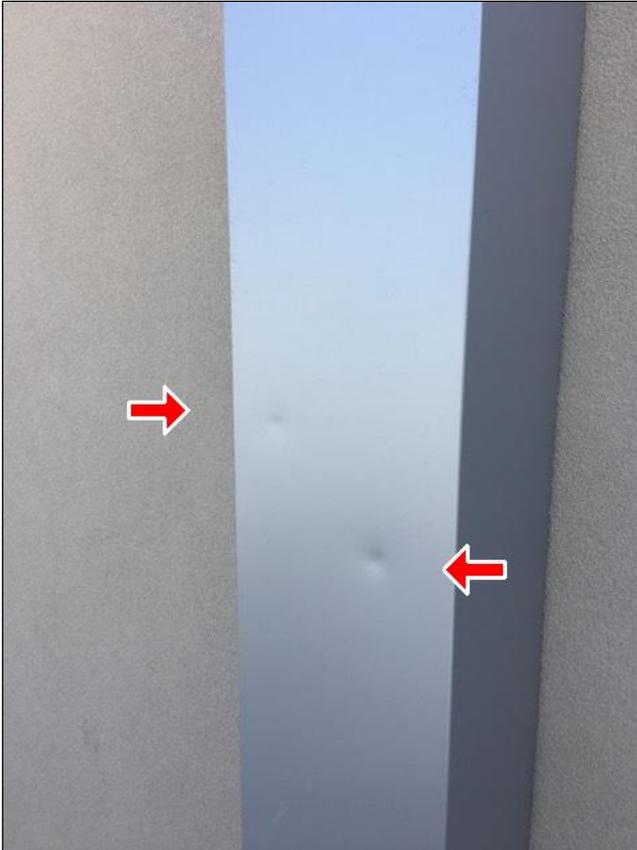
- (1) Storm drainage around the building area was flat to sloping away from the building envelope.
- (2) There was light storm damage on the downspouts on the back of the building

B. Item 1(Picture) gutter down spot

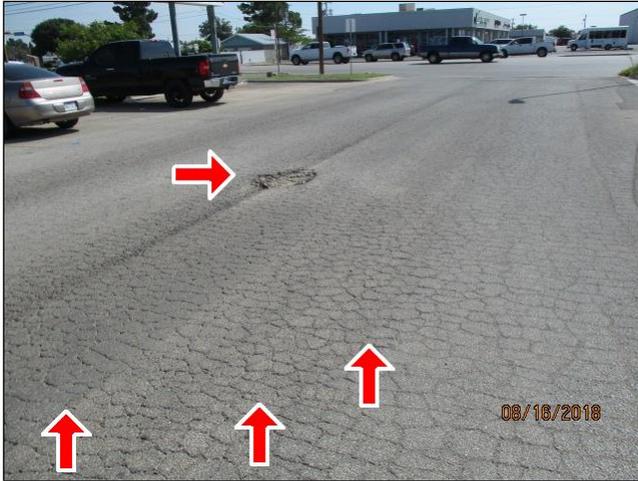
Paving around the building was in good shape. The easement that goes through the property and goes to the building behind has some damage and cracks In the pavement on the easement. I would recommend repair of the damage done in the easement by qualified contractor. (depending on where the responsibility goes tenant or the building behind the tenant).

D. Item 1(Picture) Patching and sealing required in the easement

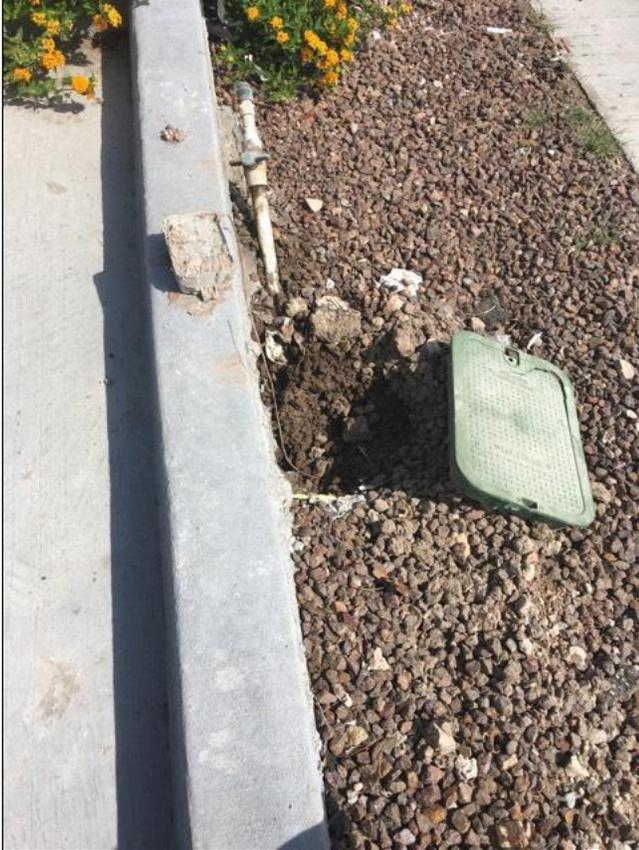
(1) The landscaping appeared to be in good condition at time of inspection. The sprinkler system on the southeast corner of the property, need some attention. A sprinkler valve is laying up on top of the curb and it appears there is a missing sprinkler box at that point. I would recommend a qualified sprinkler contractor to repair.

F. Item 1(Picture) Sprinkler damage on SE corner of property

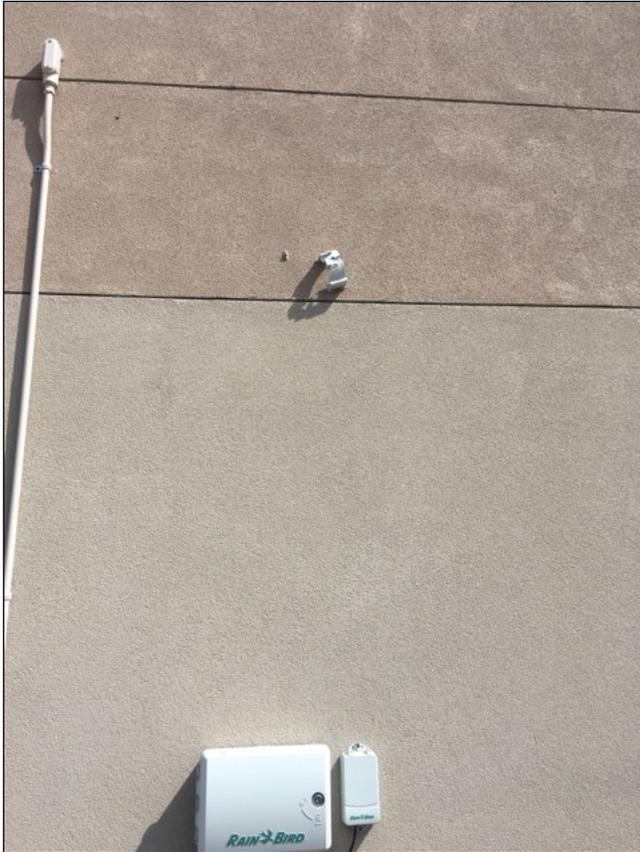
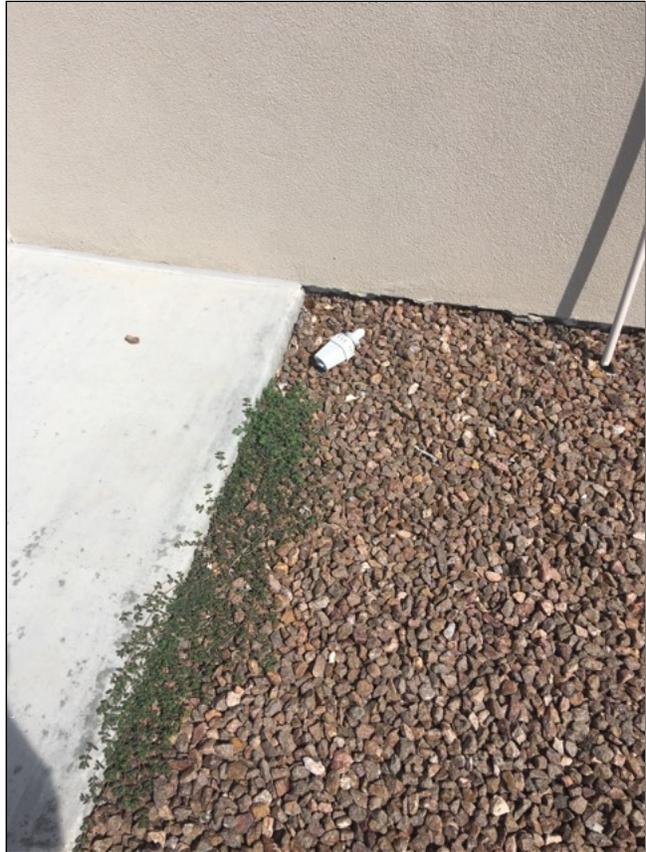
F. Item 2(Picture)

(2) The rain and freeze sensor for the sprinkler system is broke off the side of the building. I would recommend a qualified person to repair

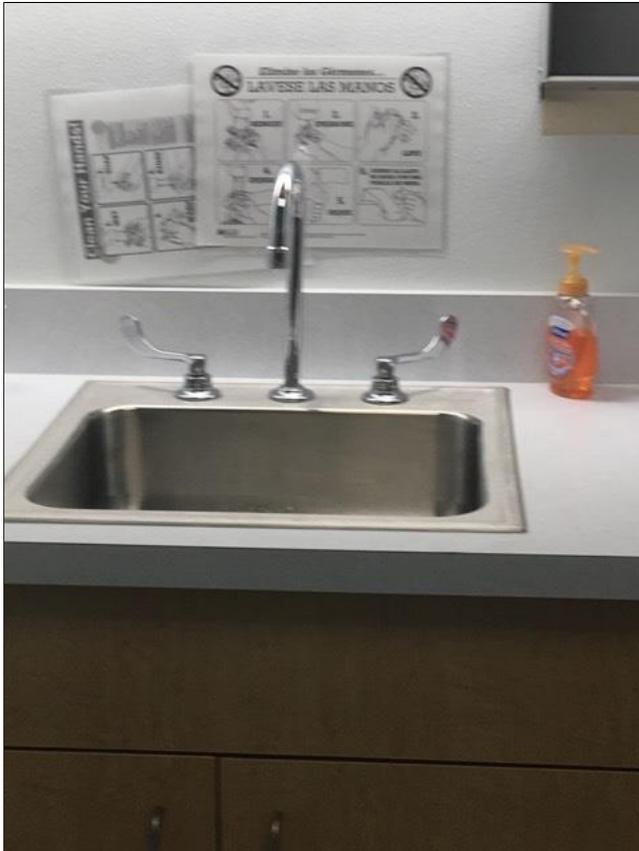
A. Item 1(Picture)

There was a sink in the soiled utility area on the Southwest corner of the building that was not working at the time of inspection.

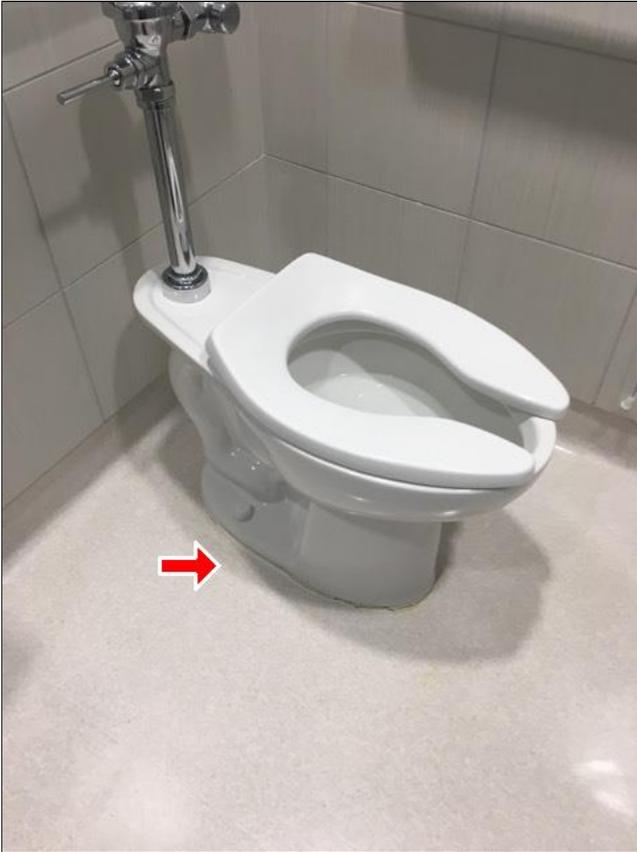
B. Item 1(Picture)

(2) The toilet was loose and the caulking was cracked around the toilet in the patients bathroom on the east wall. I would recommend a qualified plumber to repair.

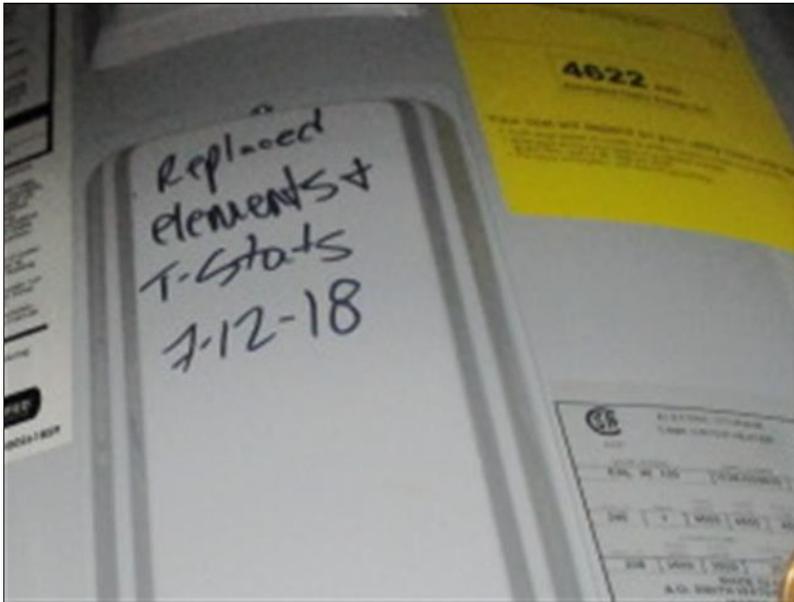
There was work done on this in July 2018

C. Item 1(Picture) Date of repair label

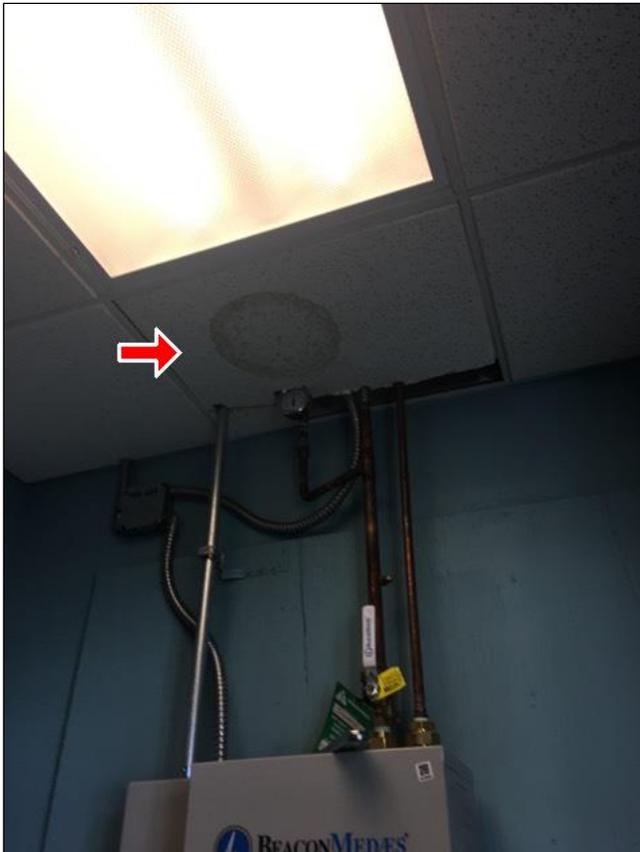
There were 3 areas that had show water stains in the ceiling tiles. The first was on the east exam room ceiling. The second was in the oxygen room. The third was in the vacuum room behind the oxygen room. I would recommend monitoring for source of leak and repair by qualified contractor.

A. Item 1(Picture) Vacuum room

There were ceiling stains in the tiles in a exam room on the east wall, oxygen room, and the vacuum room. These were cosmetic in nature. The stains were no bigger than 3 inches in diameter. I would monitor these areas for further damage. If the damage persists, I would recommend a qualified person to inspect and advise.

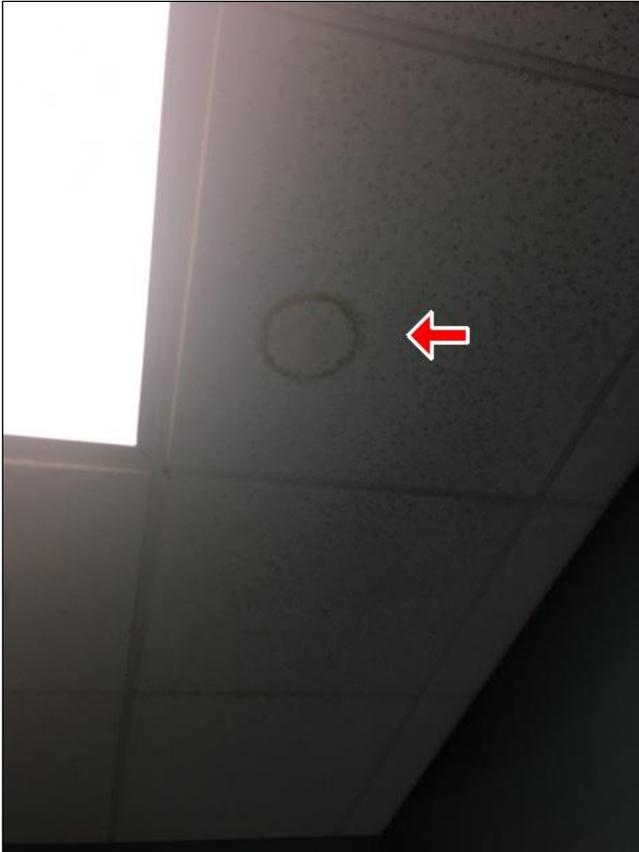
A. Item 3(Picture) exam room
